QUESTIONS TABLED FROM THE FLOOR:

MEETING HELD ON 14 June 2019

NAME	Brian Youngblood
ORGANISATION	Fish Hoek Valley Ratepayers & Residents Assoc.
CONTACT DETAILS	
EMAIL ADDRESS	bdyoungblood@gmail.com
TELEPHONE NO / CELL	0217821950/0843999933
FAX NO.	N/A
<u>ISSUE / TOPIC (1)</u>	
The following are all related to the same issue / topic.	
<u>QUESTION (1)</u>	
What is the source of the sewage entering our stormwater system grate at the corner of First Avenue and Recreation Road near the Book Worm?	
Can a surveillance camera be aimed in this area temporarily? The grate's water sampled is stagnate, yet it bubbles sulphur dioxide smelling fumes and probably methane due to the high E. coli count. If the surveillance camera does not find anything untoward, can a camera be inserted into the pipe in order to detect any incorrect sewage connections.	
<u>QUESTION (2)</u>	
What is the source of the grease found in the stormwater system behind KFC and Town Square and can this be stopped?

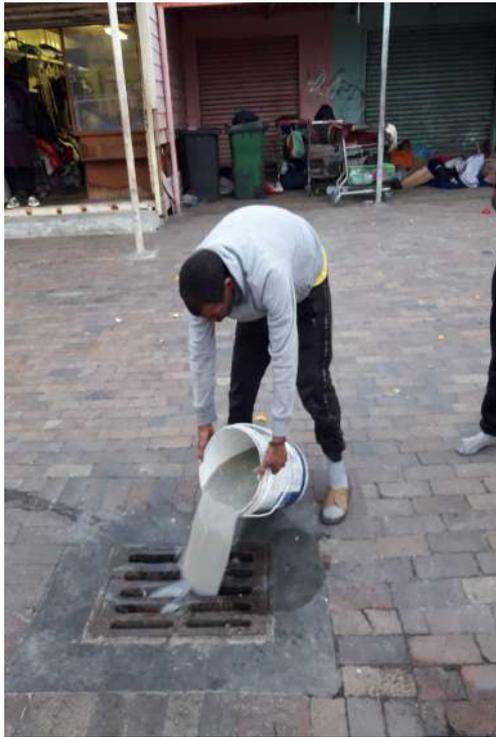
Can a "low-flow stormwater diversion grate" be installed in the Train Precinct? It is the one located in the middle of the informal traders' parking lot between the Krinros building and the train station.

"The problem is they throw all the fat & rice etc. down the drain and it only takes a week or two to block up the drains. That is why they use the storm water drains." says the owner of surveillance cameras aimed on this area. See the photo on the next page. This type of event happens several times a day and night-soil discharges have been observed.

It be a case of human convenience factor, possible socio-economic or lack of education (that stormwater flows to our beach) and defiance of authority (political or otherwise) that we are proposing the low-flow stormwater diversion grate.

The owner of the Krinros building has offered to "develop" the area for the informal traders.

Can the City's health inspectors issue fines for repeat offenders that dump food and night soil into our stormwater grates, such as in the train precinct? See photo above.

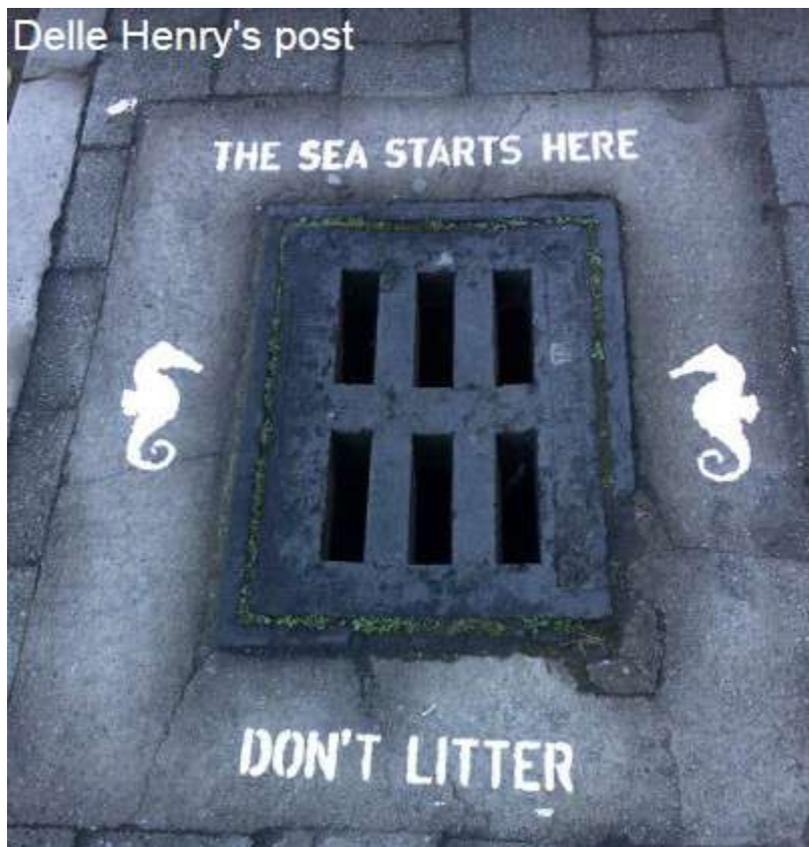
Can all the stormwater grates be stencil painted like this one?
